## Impact-Echo diagnosis in Sighisoara, Romania, bridge over Sacs

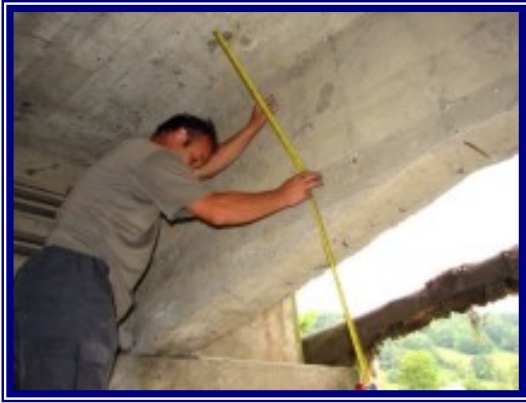
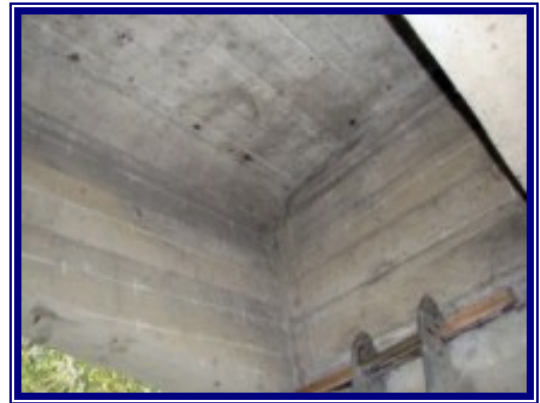
Sketching a mesh over the surface with 30 cm / 30 cm frame size :

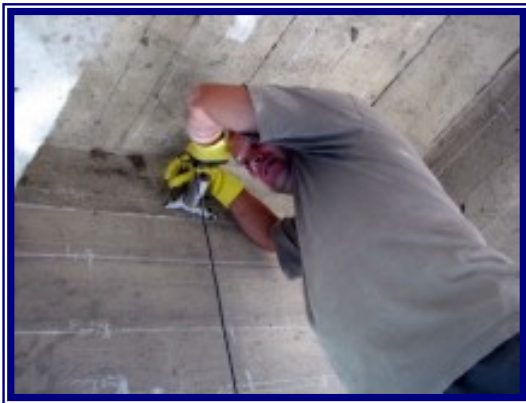
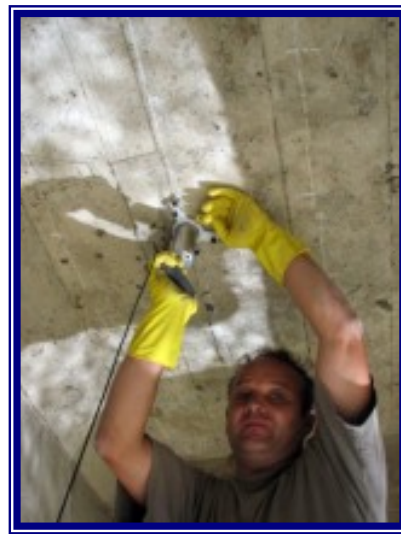
Measuring the sound speed and executing non-destructive Impact Echo tests over the bridge deck and beams :

- The 1.520 m/s sound speed measured in the concrete, shows a low elasticity modulus, under 50.000 dN/cm<sup>2</sup>
- More than 500 impact-echo tests were performed over the bridge structure.
- Several cracks were detected, with preference in the concrete beams.
- Example of three consecutive points indicating the development of a crack in the concrete beam :
